**FINAL PHASE I, II AND III
ENVIRONMENTAL SITE ASSESSMENT
MALPEQUE HARBOUR, APPROACH RANGE SITES
LL# 1066, 1067, 1068 and 1069
LDU/PN # 02175, 81101, 02176, 81102
RPIS # MB00064, MB00065, MB00066, MB00067
PRINCE COUNTY, PRINCE EDWARD ISLAND
PROJECT NO. NBF13300-0007**

**JACQUES WHITFORD ENVIRONMENT LIMITED
590 NORTH RIVER ROAD
CHARLOTTETOWN, PEI
C1E 1K1**

January 7, 2002

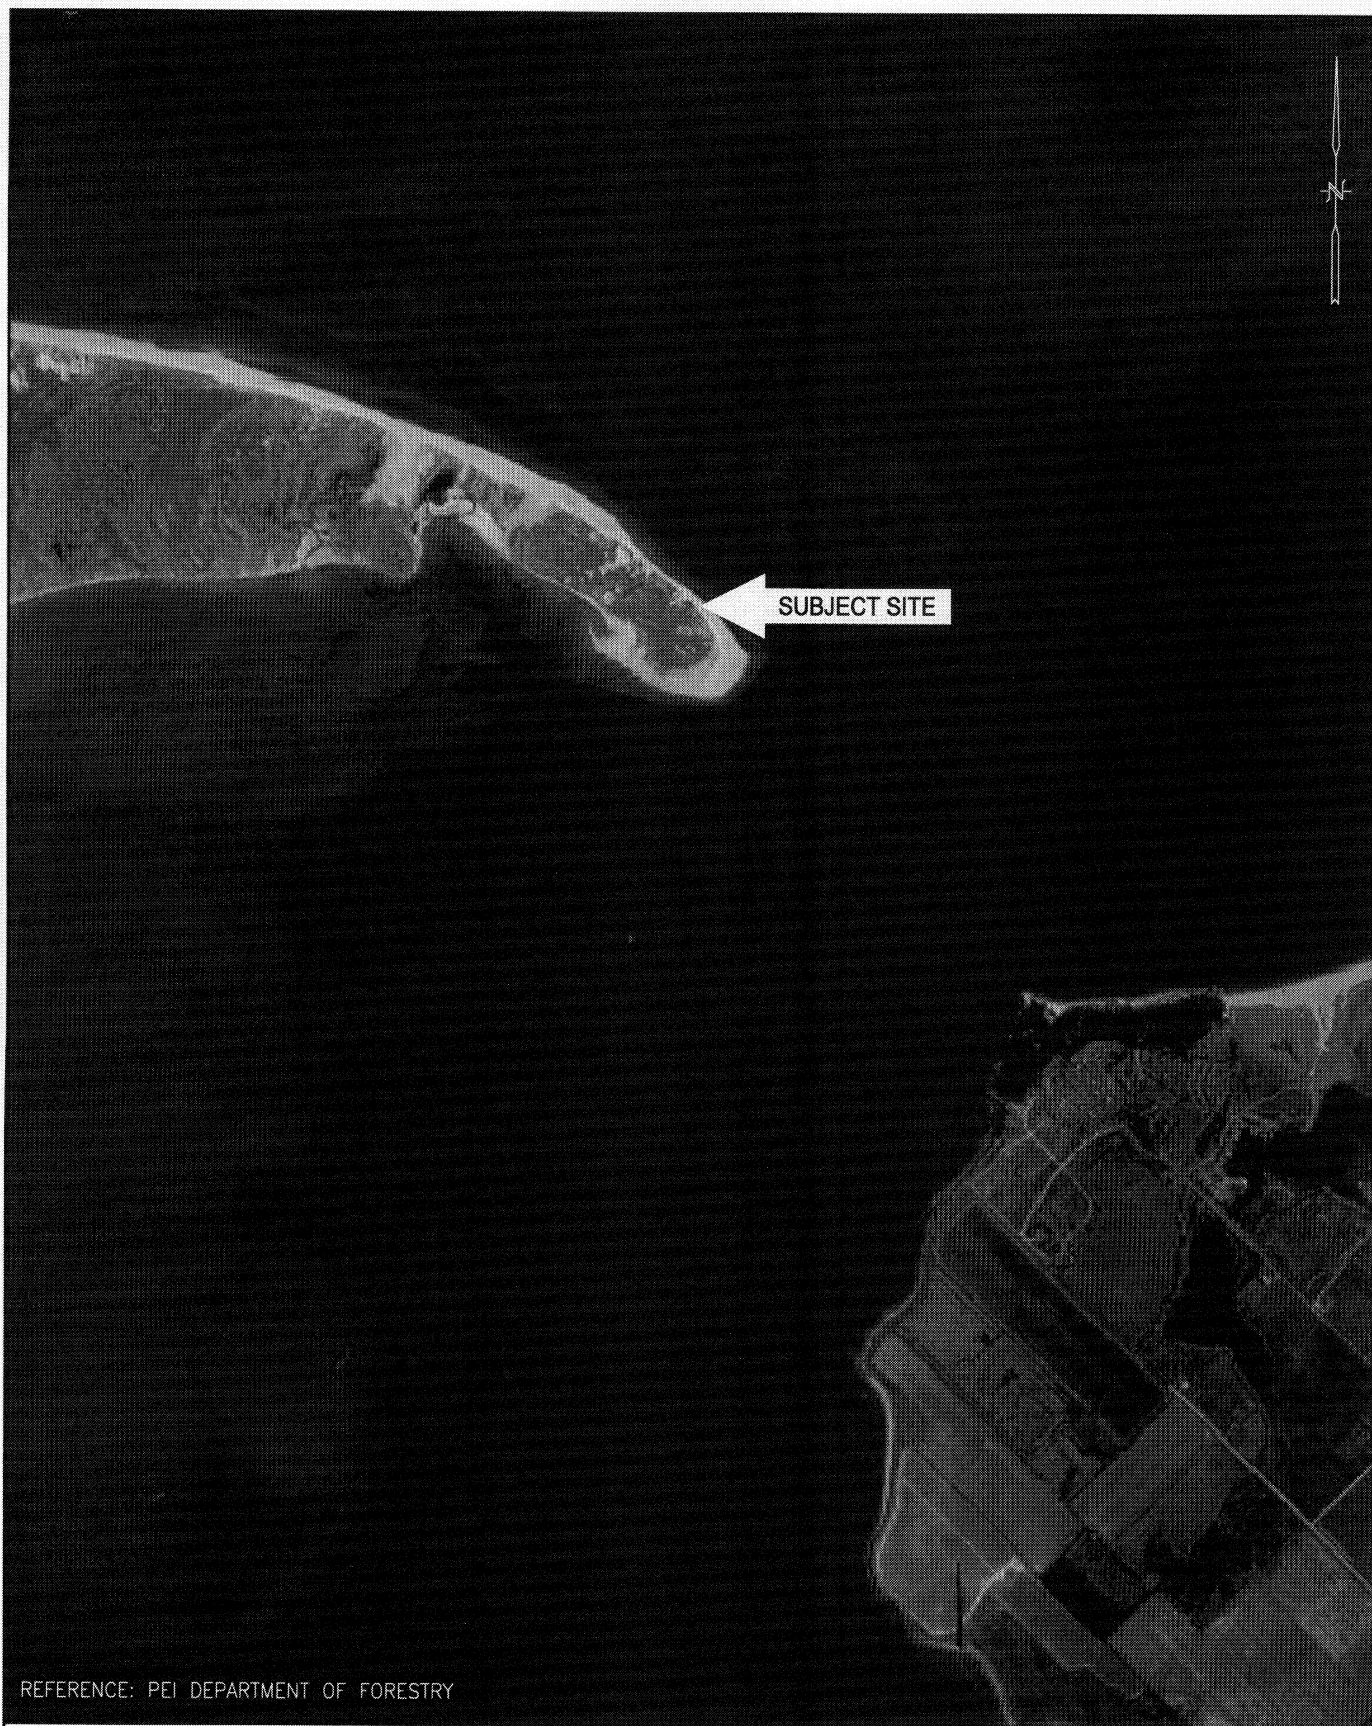
<p align="center">1994 AERIAL PHOTOGRAPH MALPEQUE HARBOUR APPROACH RANGE SITES PRINCE COUNTY, PEI, LL# 1066, 1067, 1068, 1069 LDU/PN# 02175, 81101, 02176, 81102 RPIS# MB00064, MB00065, MB00066, MB00067 DEPARTMENT OF FISHERIES AND OCEANS</p>	<p>Date: 02 01 14</p>	<p>Scale: NTS</p>	<p align="center">

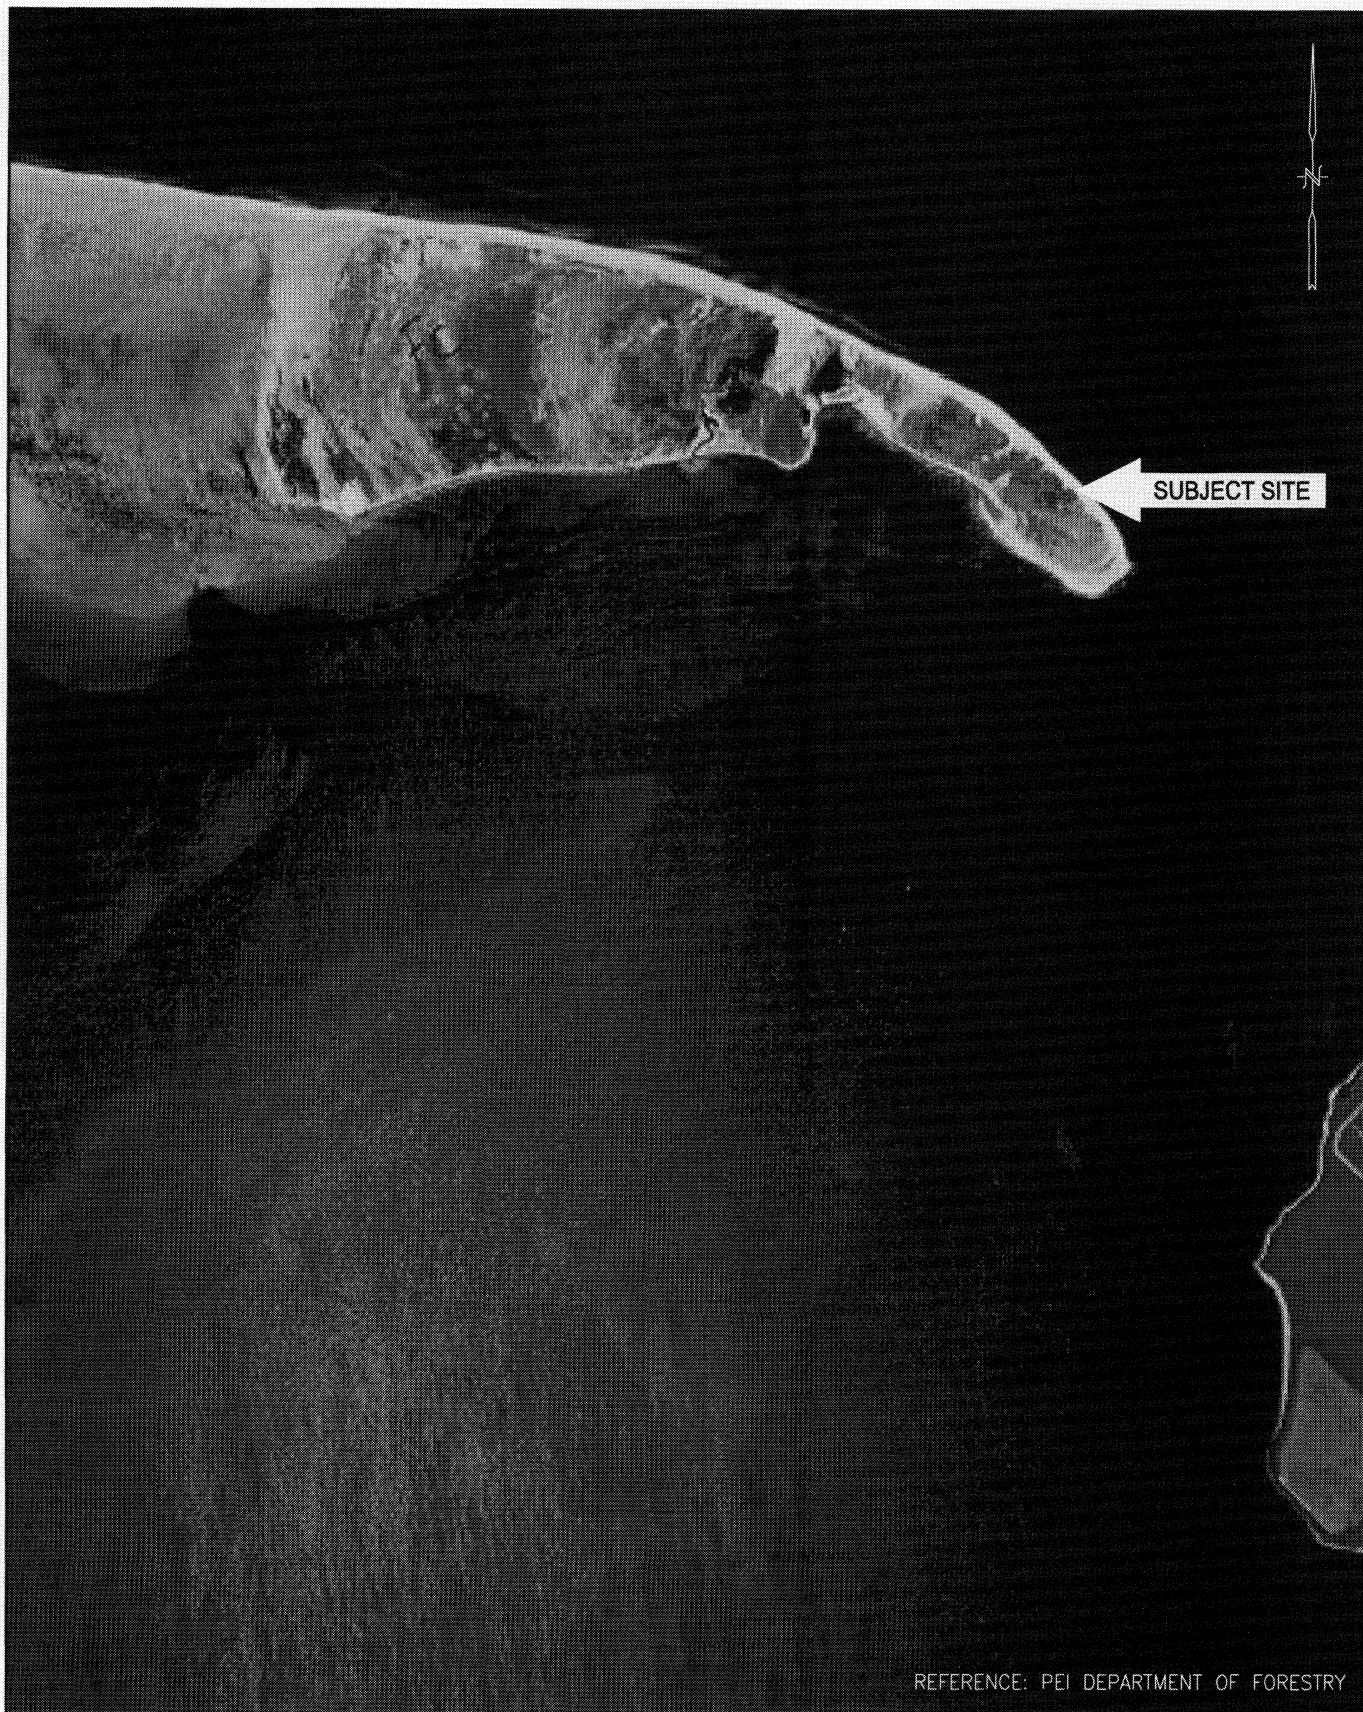
1997 AERIAL PHOTOGRAPH MALPEQUE HARBOUR APPROACH RANGE SITES PRINCE COUNTY, PEI, LL# 1066, 1067, 1068, 1069 LDU/PN# 02175, 81101, 02176, 81102 RPIS# MB00064, MB00065, MB00066, MB00067 DEPARTMENT OF FISHERIES AND OCEANS	Date: 02 01 14	Scale: NTS
